Kalevala kindergarten investment project

Thermal imaging survey – before and after

Demonstration object: kindergarten №2 «Ruchee» in Kalevala settlement

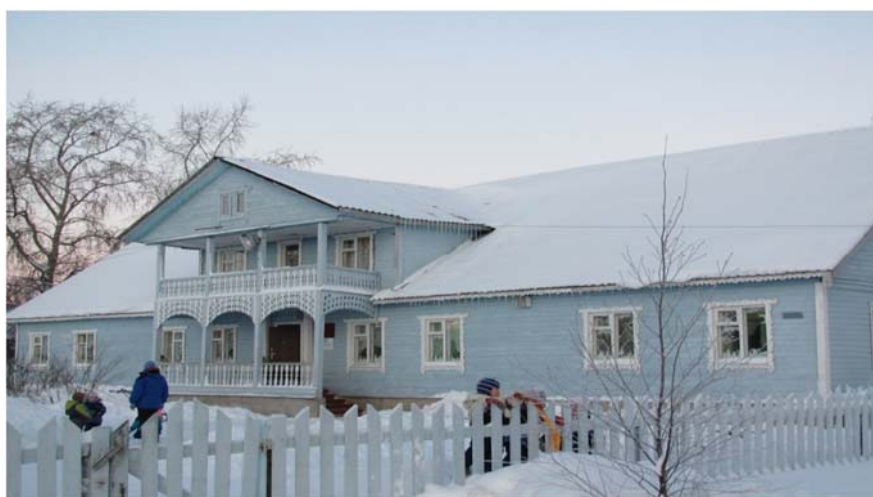
- commissioned in 1992;
- two-store wooden building in the central part and one-store on the sides;
- area - 306 m²;
- heating system - by circulating hot water heated by the electric boiler ;
- personnel – 10 people;
- number of children (aged 3 to 7 years) – 50.

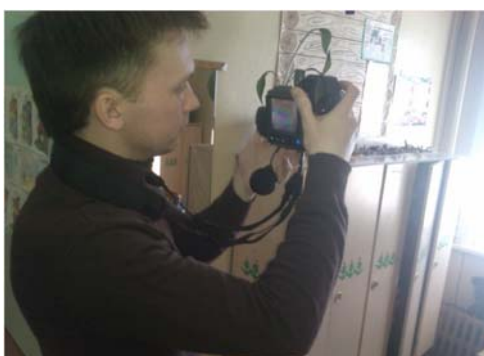
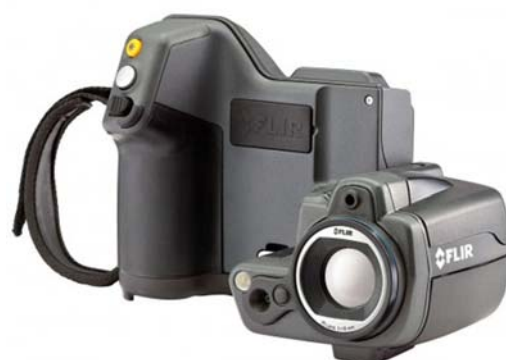
- Was made on April 5, 2013
- Included the survey of inside and outside surfaces of the walls
- Revealed latent defects in the constructions, heating insulation breaches spots, air infiltration, moisture standards violations
- Survey was made by means of FLIR T420bx imager.

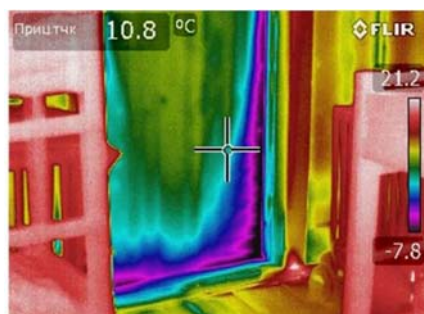
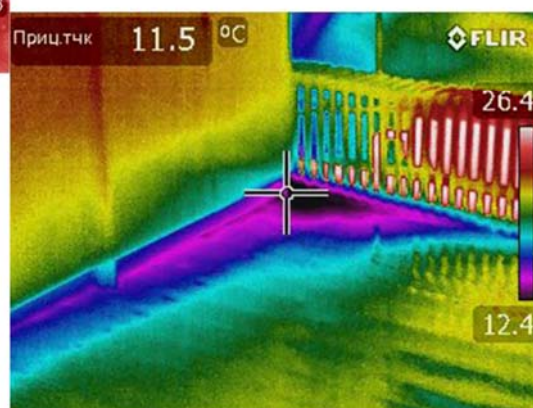
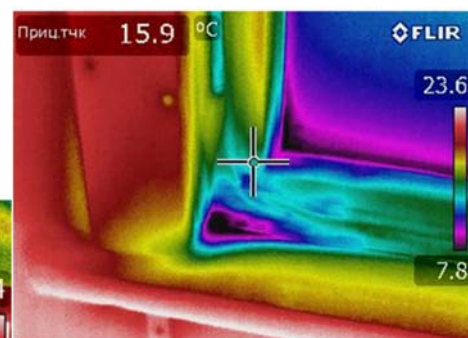
The heating loss spots were detected.

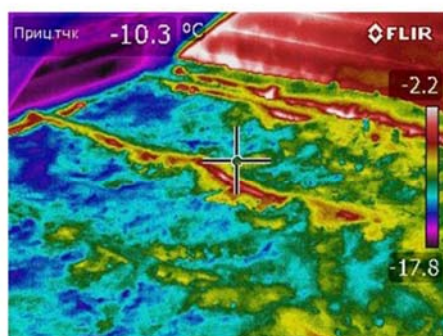
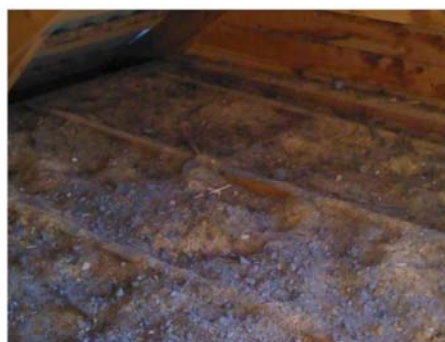
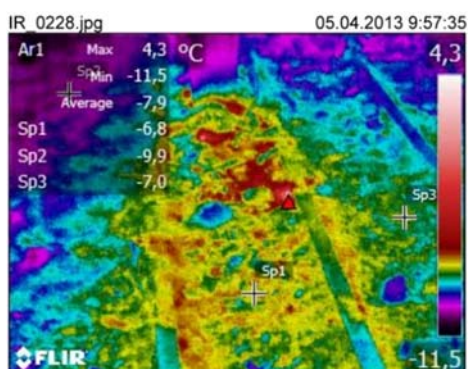
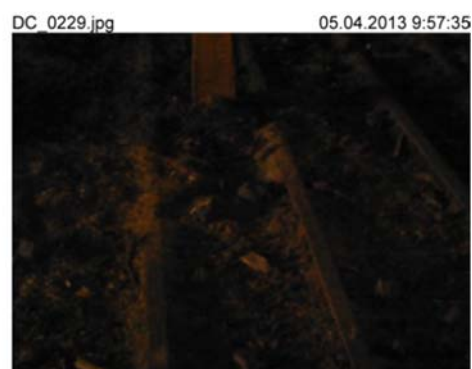
The most extensive areas of heat loss were detected in the attic floor areas.

- Originally wooden sawdust with the irregular layer thickness of 150-200 mm were used as the attic floor heat insulation material.
 - Chips density – $300\text{--}350\text{ kg/m}^3$
 - Heating conductivity - $0,095\text{ W/m}\times^{\circ}\text{C}$
- It was suggested to replace sawdust for basalt mineral wool with the layer of 200mm thickness (2 layers 100 mm each).
 - The wool consists of extremely thin (3-5 mm thick) interwoven fibers forming the cells that contain the air.
 - Wool density – 30 kg/m^3
 - Heating conductivity - $0,038\text{ to }0,042\text{ W/m}\times^{\circ}\text{C}$

- Made during summer 2013,
- Completed in August 2013,
- Sawdust were removed from the attic floor ,
- Steam insulation material laid down and fixed,
- On top 2 layers of overlapping basalt mineral wool Paroc UNS 37 panels $600\times1200\times100\text{mm}$ were laid,
- The upper layer was protected by steam insulation material.

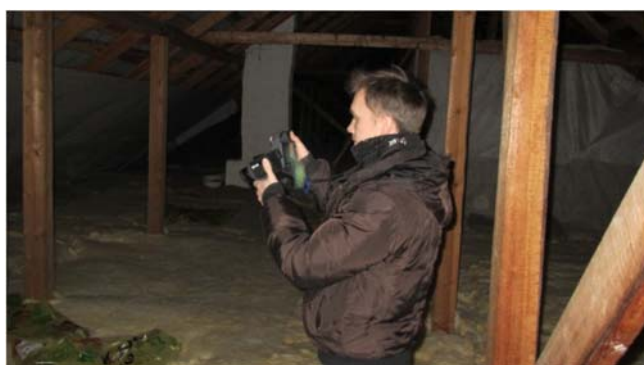
- Was made to compare the heat loss before and after the energy saving activities
- Was made on January 22, 2014
- The temperature rates during the first and the second surveys were matching:
 - room temperature was $+24^{\circ}\text{C}$
 - outdoor temperature was around -18°C

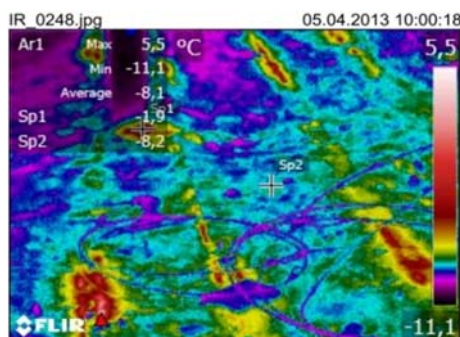
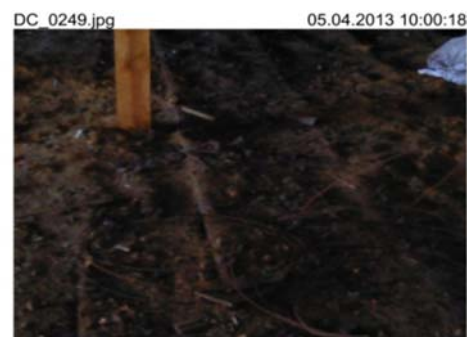
Before (Average temperature -8.1°C)

- insulation surface temperature in the attic floor decreased for $3\text{-}5^{\circ}\text{C}$

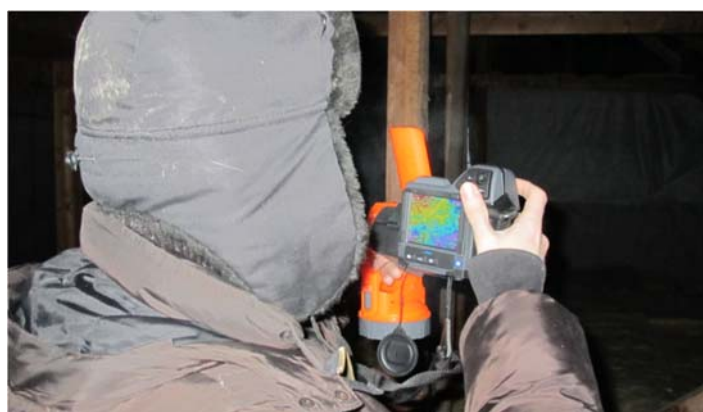
- Thermograms show the heat loss decreased.
- Rough calculation show the energy consumption should have decreased for 15-19%.
